MSC APOLLO 13 INVESTIGATION TEAM

SPACECRAFT INCIDENT INVESTIGATION

VOLUME I ANOMALY INVESTIGATION

JUNE 1970

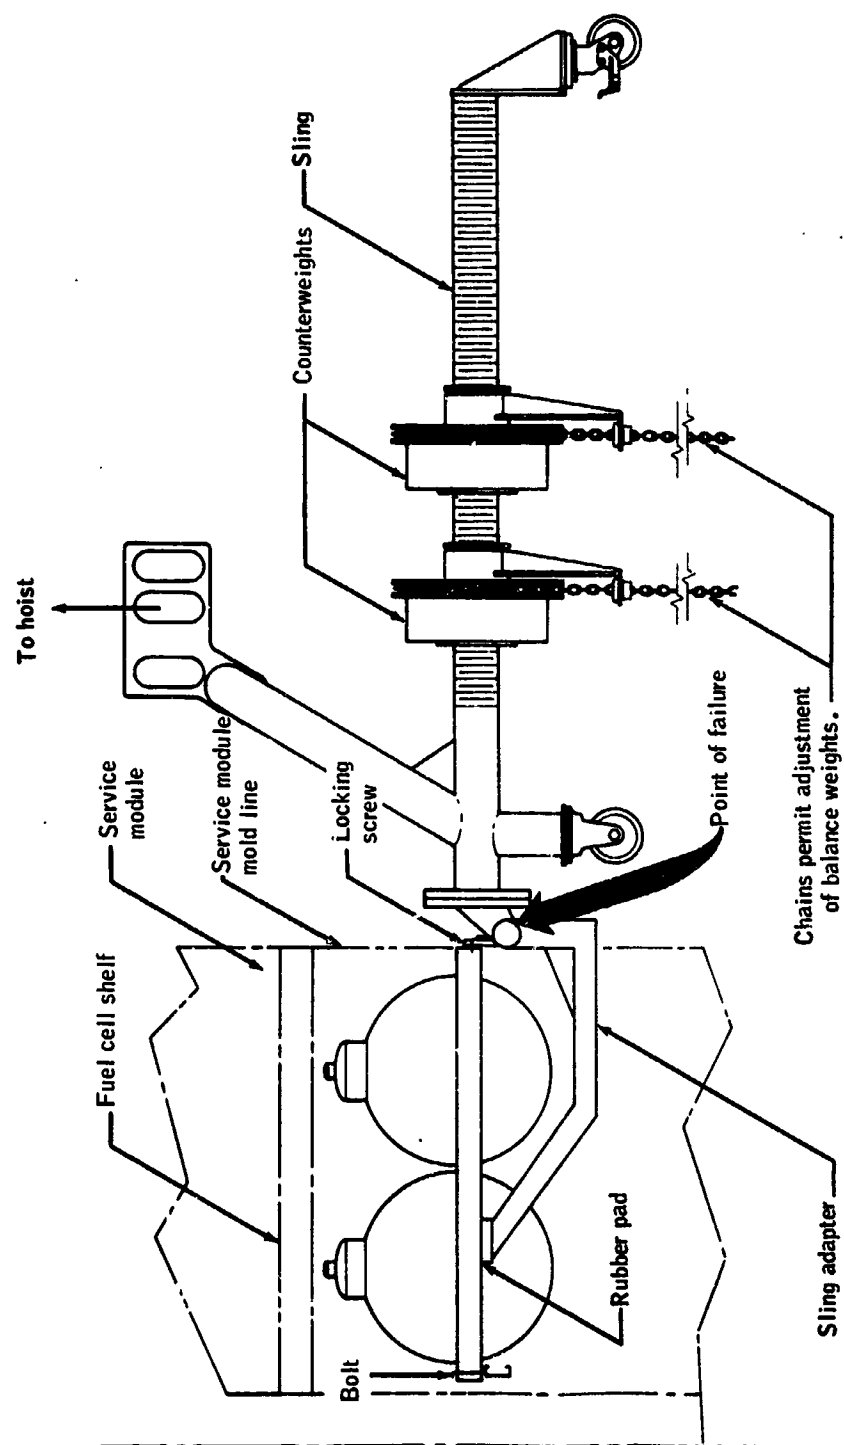
Figure 5-1.- Oxygen shelf and hoist assembly.

A detailed assessment was also made of the incident where the oxygen shelf hoist assembly failed during the factory removal of the tank shelf from the Apollo 10 spacecraft (fig. 5-1). Analysis and test show that the maximum shock upward would be about 7 g's, and the maximum shock downward would be about 15 g's. Analytically, the components within the tank would be expected to withstand 100 g's shock. Consequently, this condition is not believed to have contributed to the ultimate failure of the tank in flight.

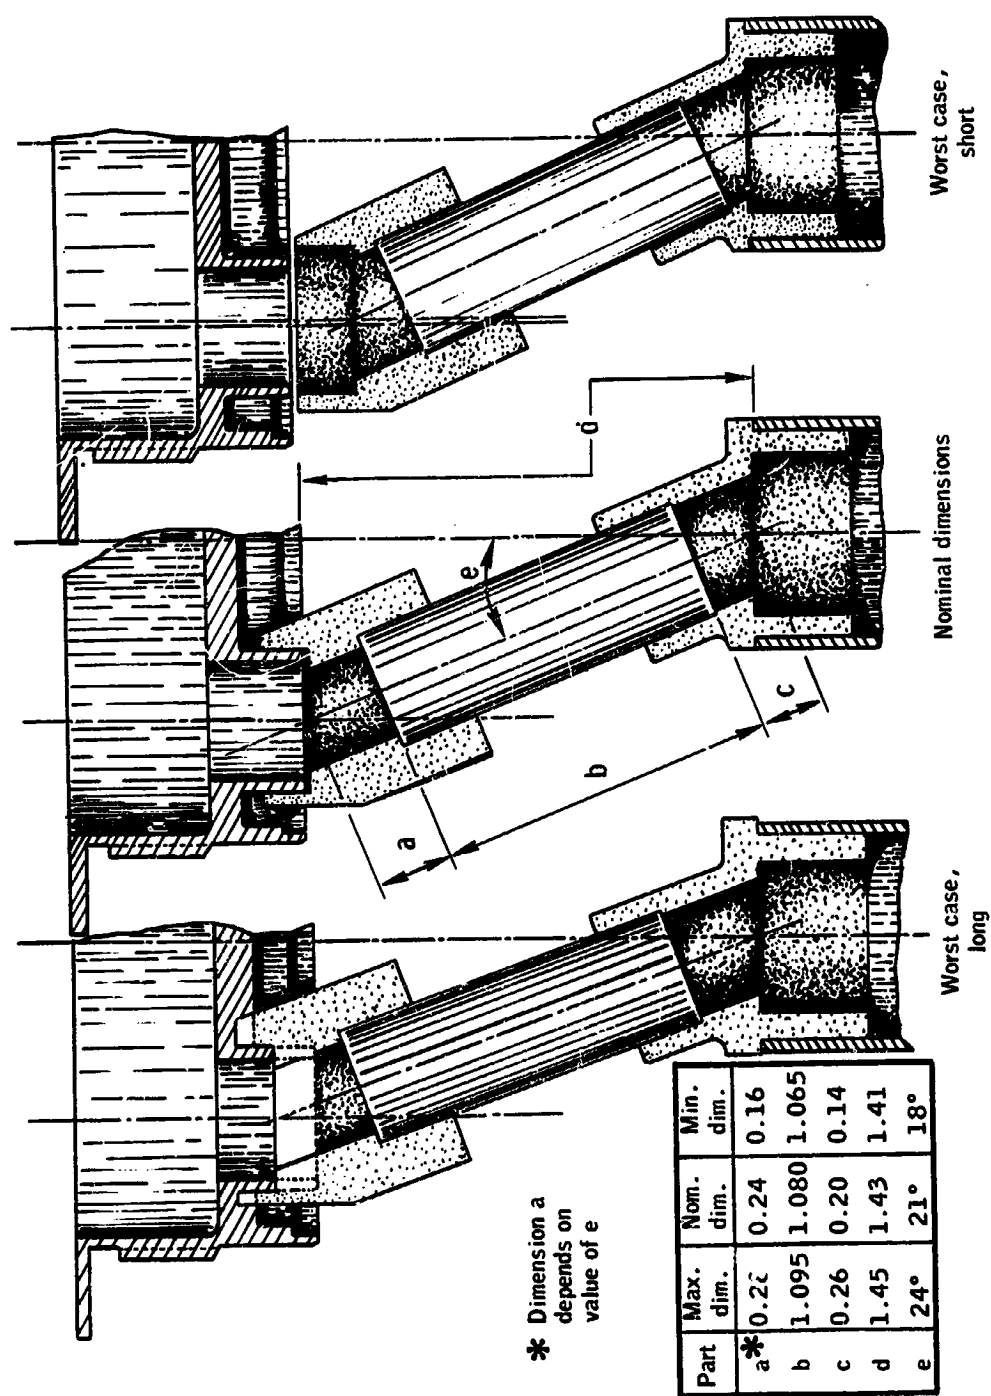
Figure 5-2.- Manufacturing tolerance study.

The cryogenic oxygen tank 2 could not be off loaded after the initial filling during the countdown demonstration test using the normal procedures. The problem resulted from loose or misaligned plumbing components in the dog-leg portion of the tank fill path (fig. 5-2). Allowable manufacturing tolerances are such that the tank may not be detanked normally under these conditions. A test has verified this fact. The condition of loose plumbing in the probe assembly, which existed in the tank before the detanking, was judged to be safe for flight in every aspect.

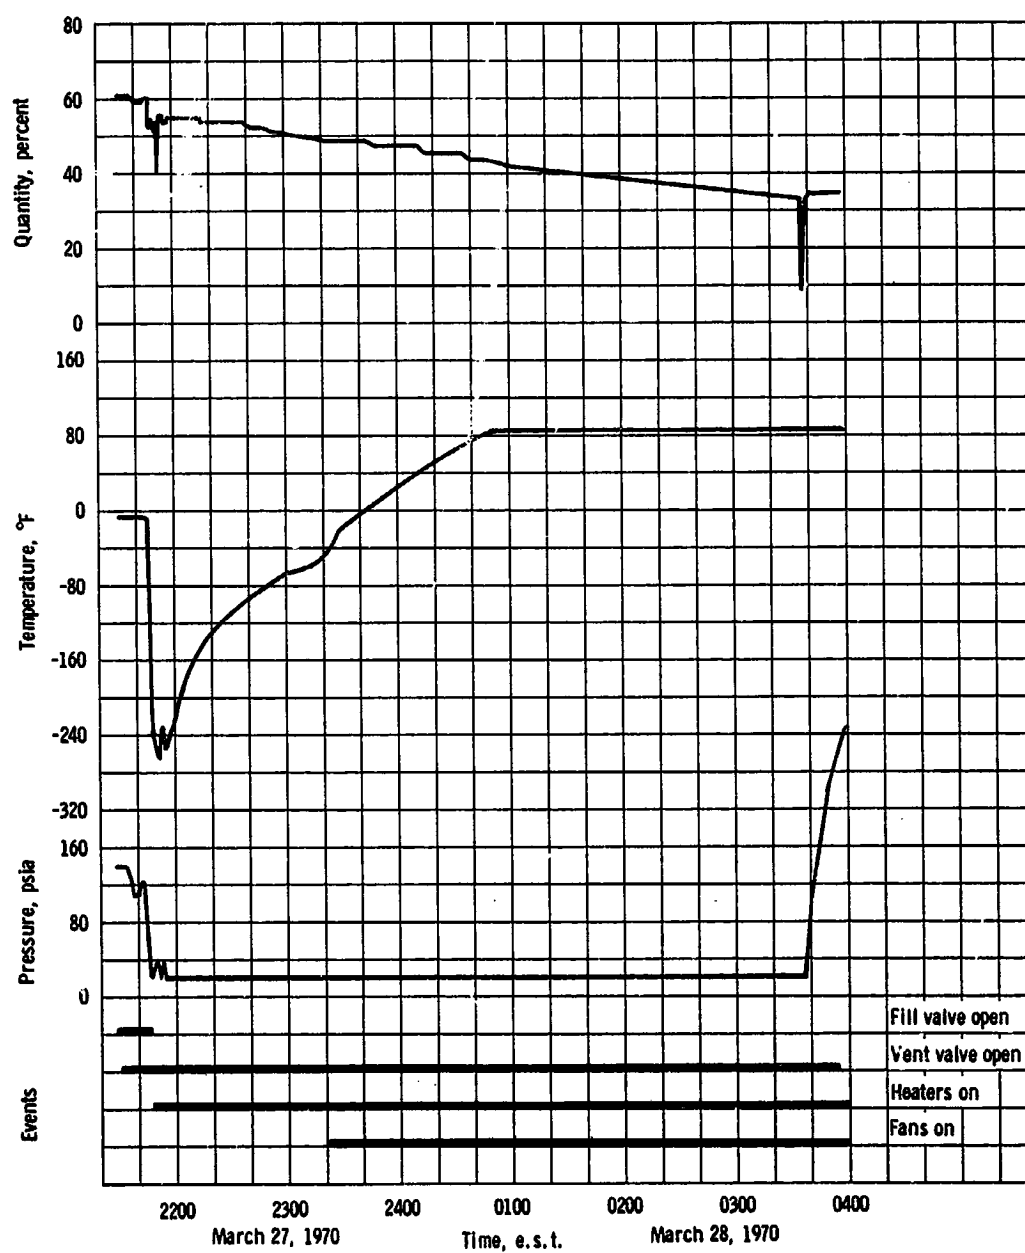
Figure 5-3. - Characteristics of oxygen tank 2 detanking using fans and heaters (CDDT).

After numerous attempts with gaseous oxygen purges and higher expulsion pressures in an attempt to remove the fluid, the fluid was boiled off through the use of tank heaters and fans, assisted by pressure cycling. The sequence of detanking is shown in figures 5-3 and 5-4. The heater-on time was about 8 hours. It was thought that no damage would be sustained by the tank or its components because of the protection afforded by the internal thermal switches.
